Docket No. 217 – Development and Management Plan Inspection

Northeast Utilities Service Company Certificate of Environmental Compatibility and Public Need for the construction of a 345-kV electric transmission line and reconstruction of an existing 115-kV electric transmission line between Connecticut Light and Power Company's Plumtree Substation in Bethel, through the towns of Redding, Weston, and Wilton, and to the Norwalk Substation in Norwalk, Connecticut.

Norwalk Substation

Date: June 20, 2006

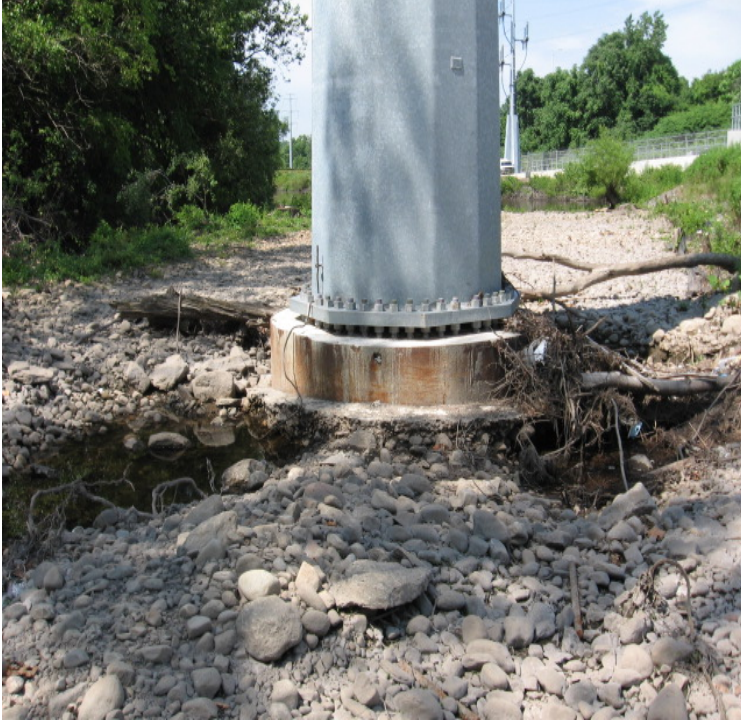
Norwalk Substation: Photo on the left shows a view of the 345kV turning structure with the adjacent erosion. This should be checked and repaired if feasible. Photo on the right shows a view of the inlet on site where stone was placed in an effort to filter run-off. 6/20/06.

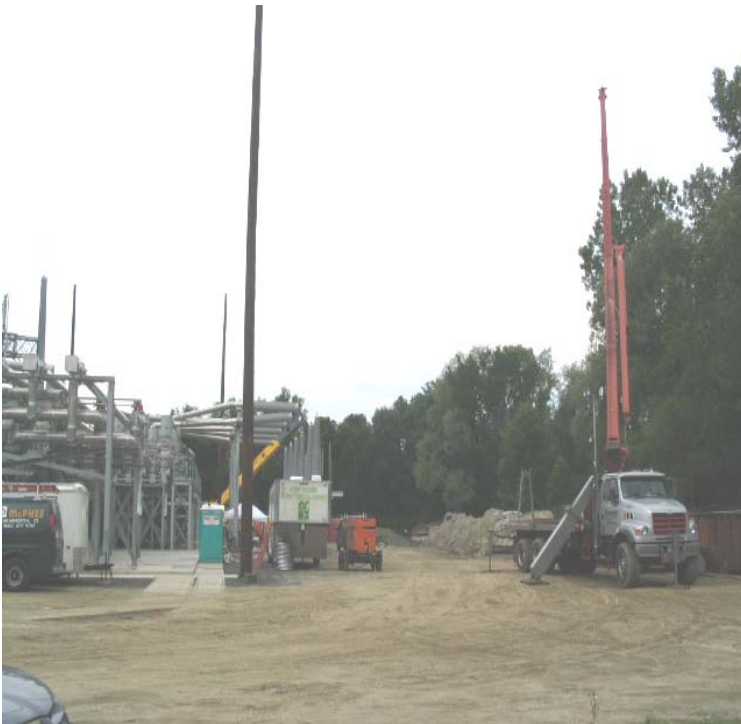
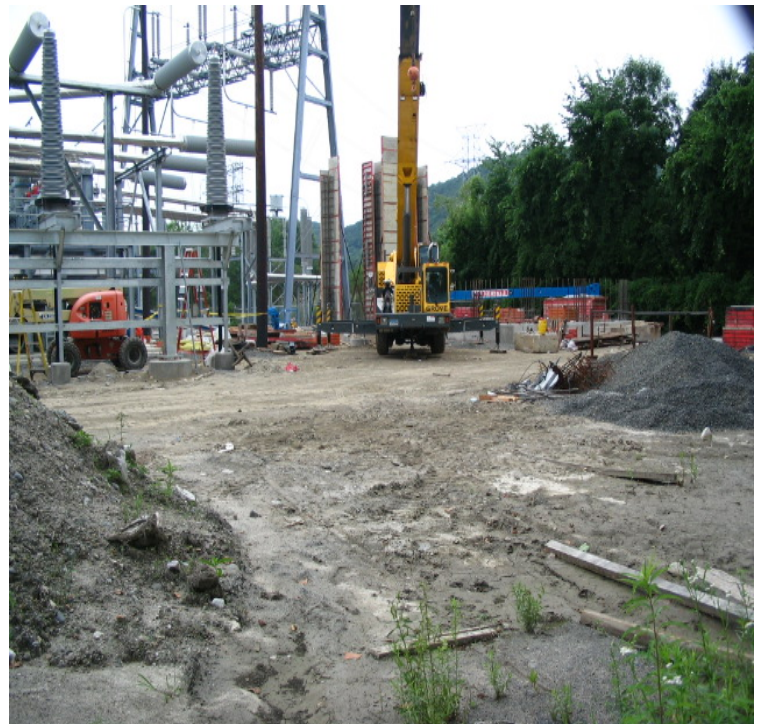
Plumtree Substation: Both photos show an overview of the ongoing work within the station yard. Several stockpiles remain, structure work continues, and there was some general site clean-up occurring. 6/20/06
